**Report of the
Playground Safety and ADA Audit
For the Billings Park Playground
Edinboro, P
November 2015**

**Audit and Analysis conducted by
Pashek Associates
Community and Recreation Planners,
Pittsburgh PA**

Billings Park Playground

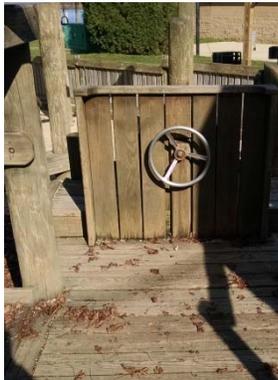
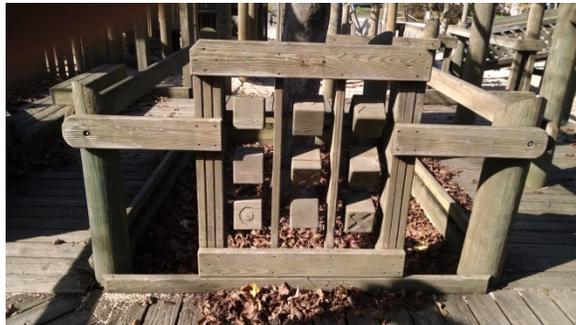
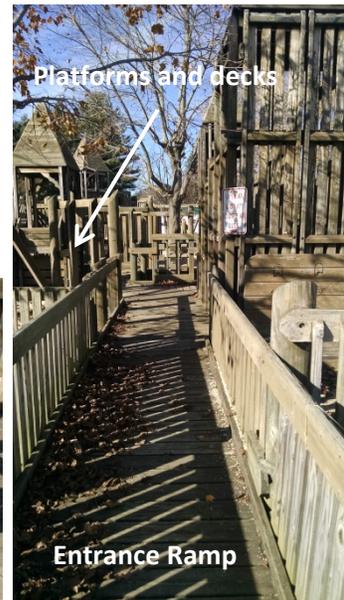
It is important to note that this playground is deficient in nearly every manner when evaluated against the 2010 ADA Guidelines. There is a mostly compliant accessible route located at the southwest corner of the play area. It leads from the entrance a series of platforms and decks, and two accessible play components. The ramp meets the minimum width and is within the maximum allowable slope but does not have appropriate hand rails.

Even if the ramp were brought into full compliance, the number of play components to which it leads is not sufficient for a playground of this size. As well, the ramp violates playground safety standards as it is located within the use zone of the adjacent play equipment.

As well, there is no accessible route from the street or parking lot to the ramp at the entrance to the play area. This means that a person with disabilities may not even be able to get to the playground entrance.

It would be extremely difficult and costly to bring the existing play area into compliance with ADA standards.

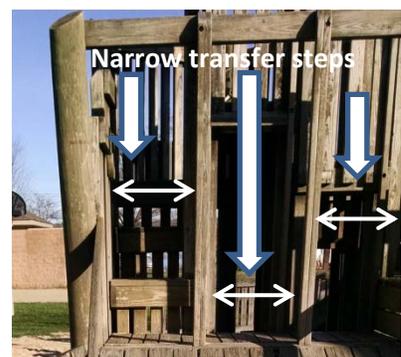
Where the ramp meets the accessible platforms and decks,

accessibility to play components beyond there is via a series of small elevated platforms, many of which are smaller than the required to meet the ADA standards. The standards require that transfer platforms/steps from one component to another be a minimum of 24" wide and 14" deep. Many of the platforms in this playground are much smaller, some as narrow as 17" and many at only 20" wide. There is clearly inadequate maneuverability space on the elevated components of this equipment.

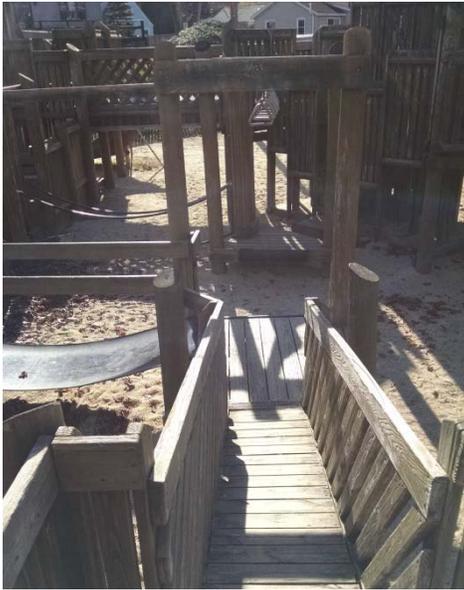
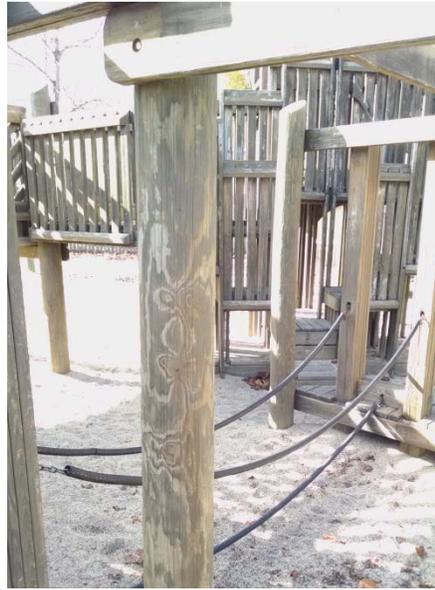
While pea gravel is an acceptable protective safety surface, it requires a minimum of 12" of pea gravel across the entire use zone of the playground. Less than three inches of pea gravel can be found in most places on this playground.

The photos below offer a glimpse of the magnitude of the amount of safety surfacing and the extensive nature of poles and equipment where the surface needs to be replaced. This is not a project that can be only partially done. The entire surface must be replaced.

To try to replace the existing surface without replacing the entire playground would require extensive manual excavation to dig to a minimum of 12" and replace all of the safety surfacing to an appropriate level. The specific depth of the safety surface will be determined by the type and height of the play equipment being used. And, as you will see in reading the remainder of this report, much of the existing equipment needs to be replaced as well.

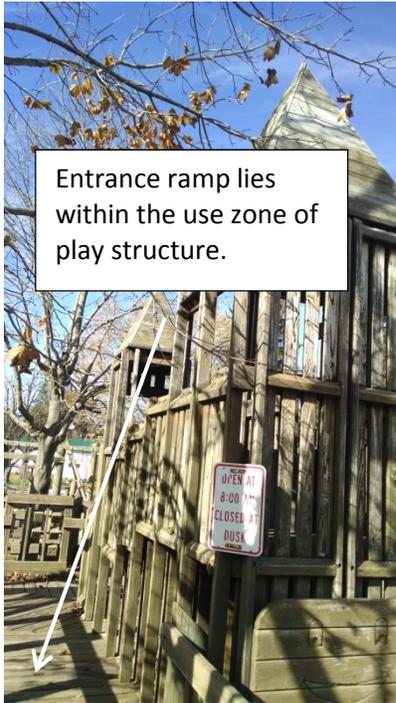
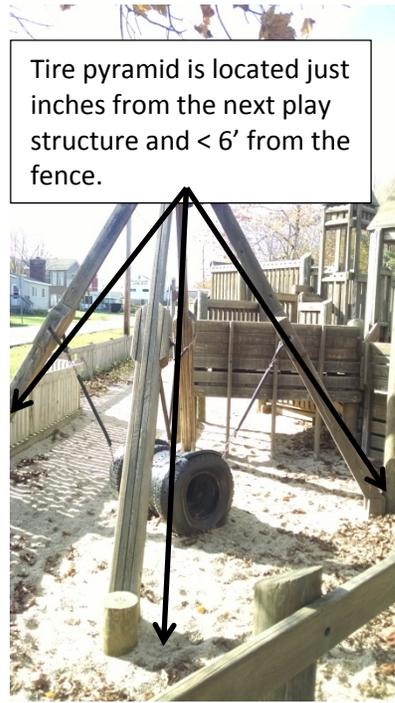
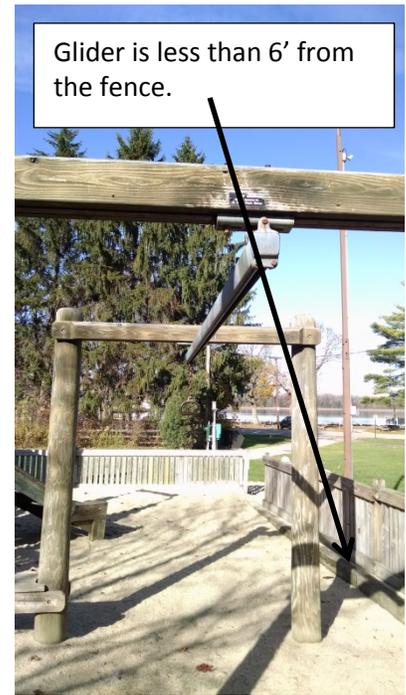
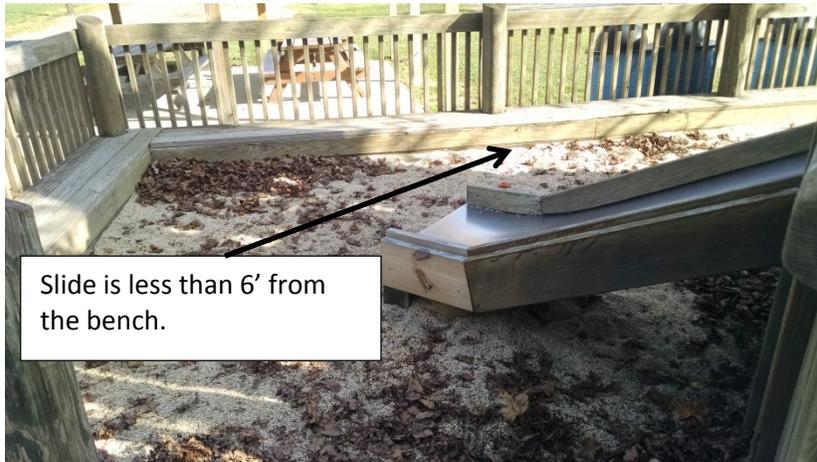
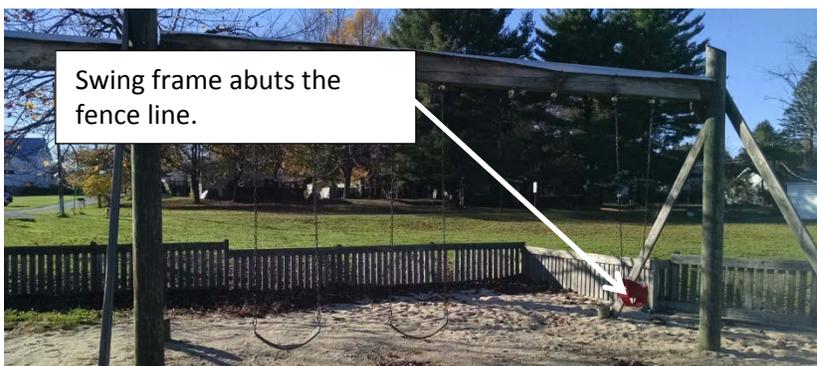
General deficiencies of the use zone

There are as many as 30 instances of inadequate use zones. Most cannot be repaired without removal of equipment, relocation of the fence, or removal of multiple pieces of equipment.

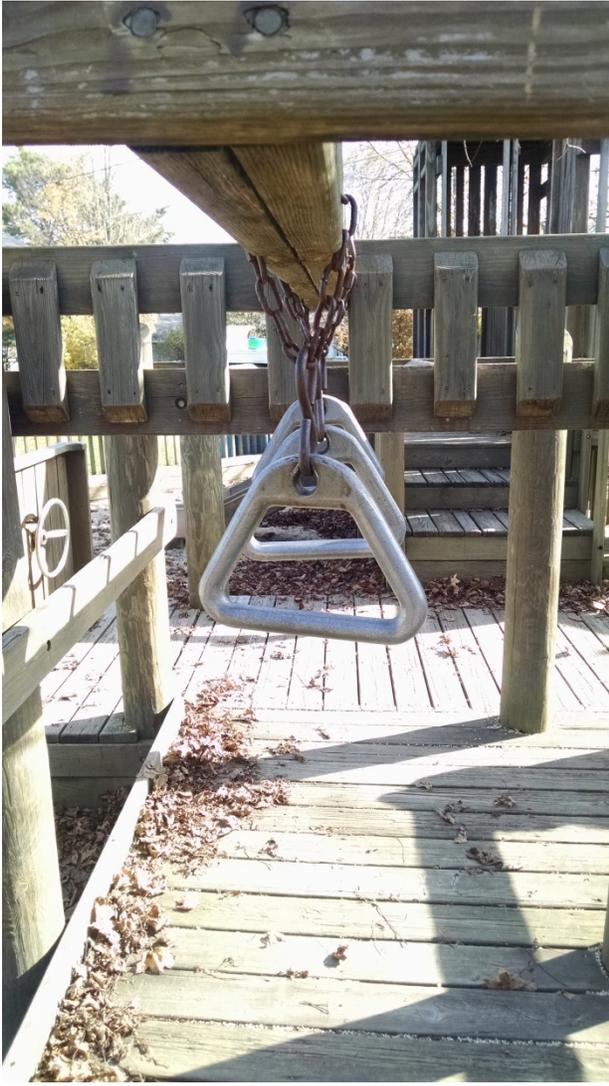
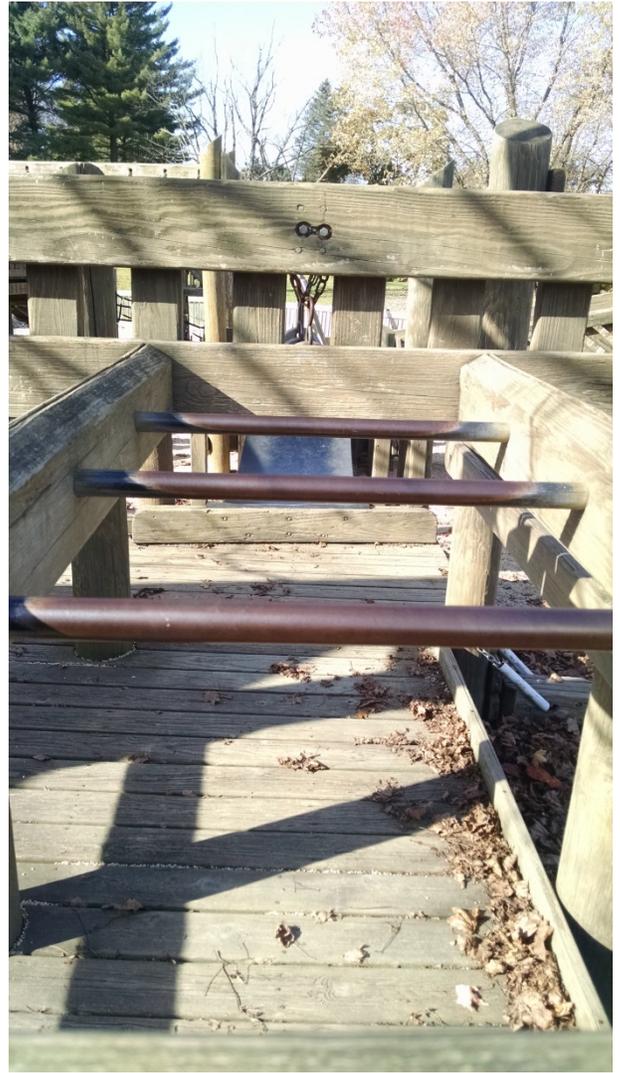
No safety surface under rings or horizontal ladder.

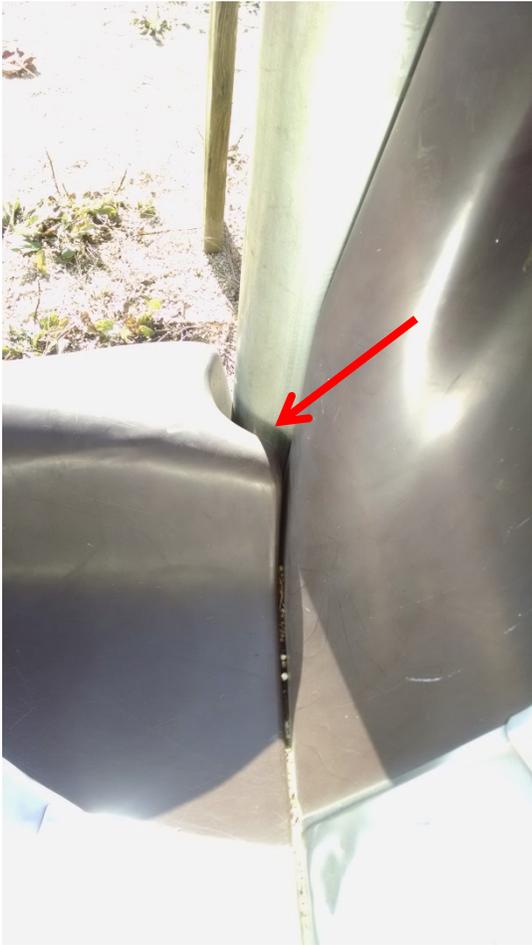
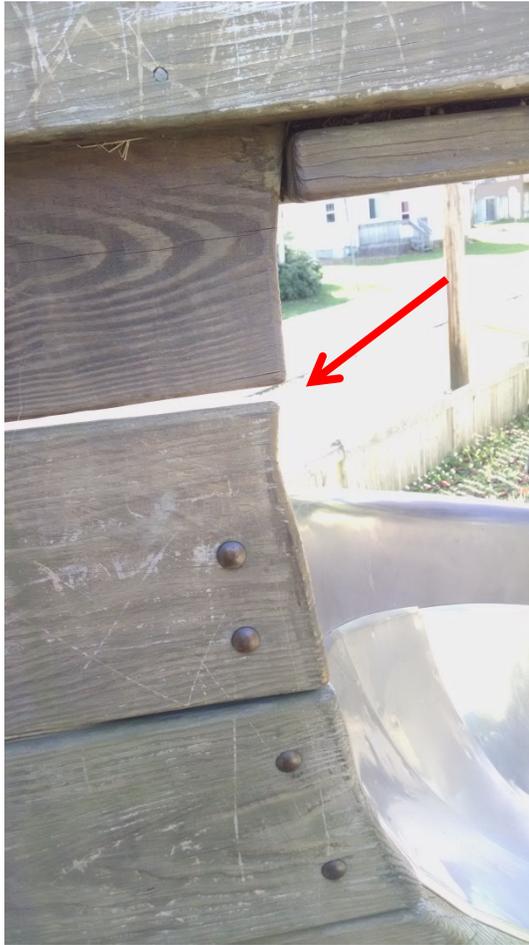
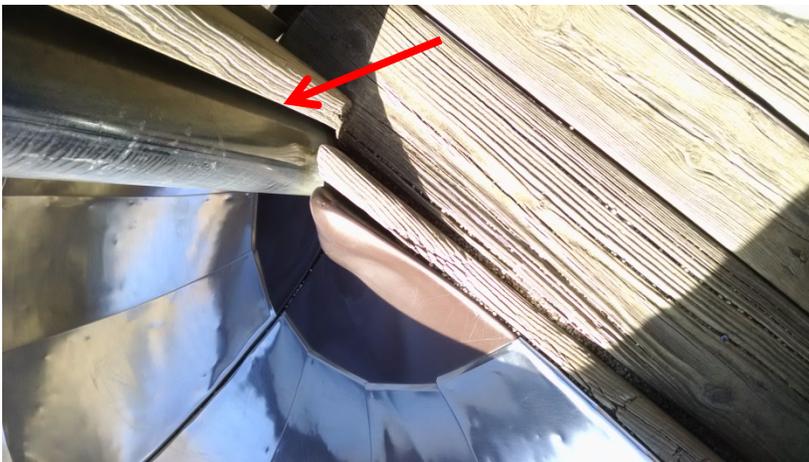
It is important to note that ALL slides in this playground have gaps between the top on the slide and the frame of the equipment. In most cases, these gaps are entanglement hazards where a string from a hoodie, a hood, or other item of clothing could become entangled, drawing the clothing around a child's neck and creating a potential strangulation hazard.

All of these gaps are found on the spiral slide in section 1.

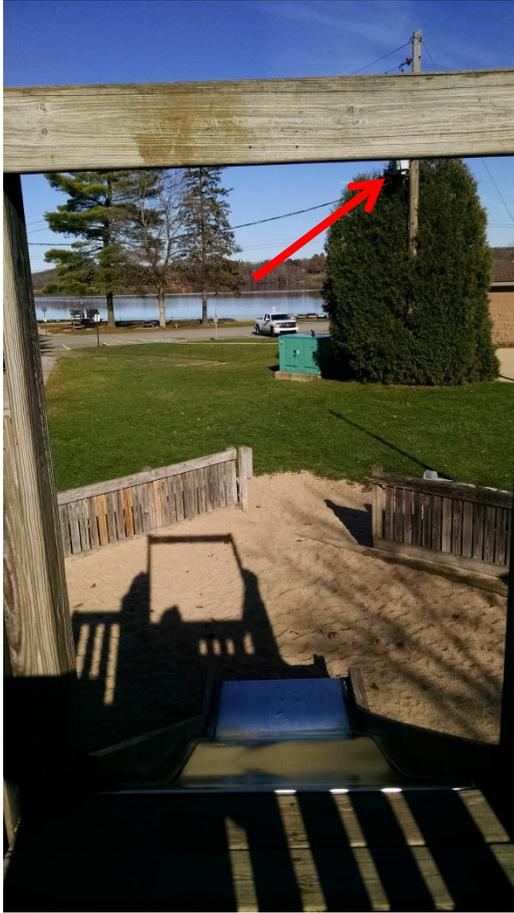
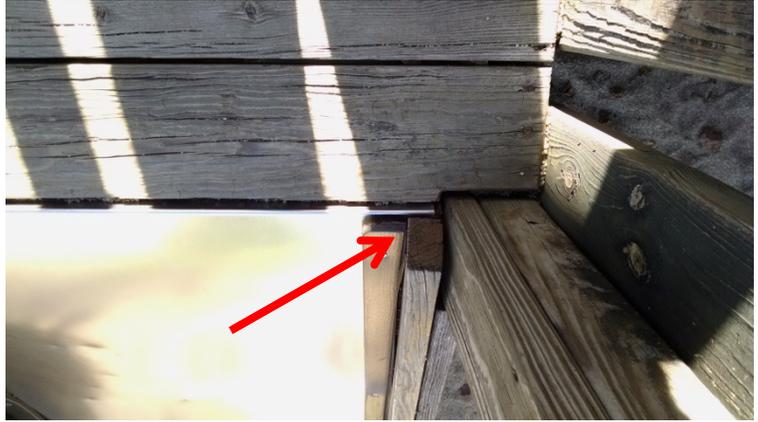
North slide in playground section 2

Entanglement hazard gap between the frame and the slide

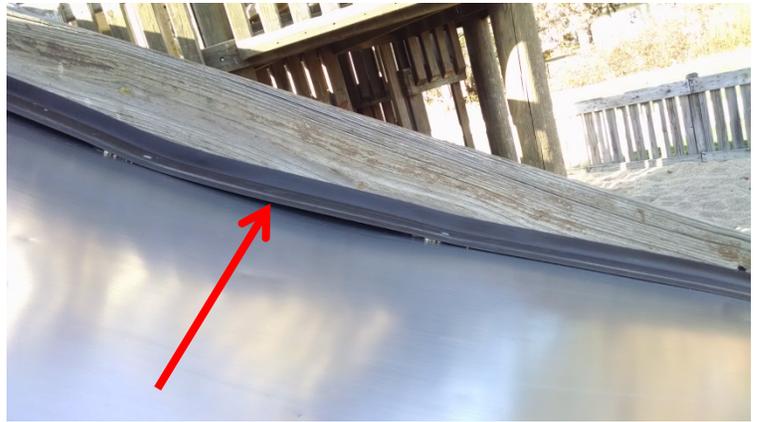
Edging added by owner creates an entanglement hazard

Potential head injury from protruding bolt

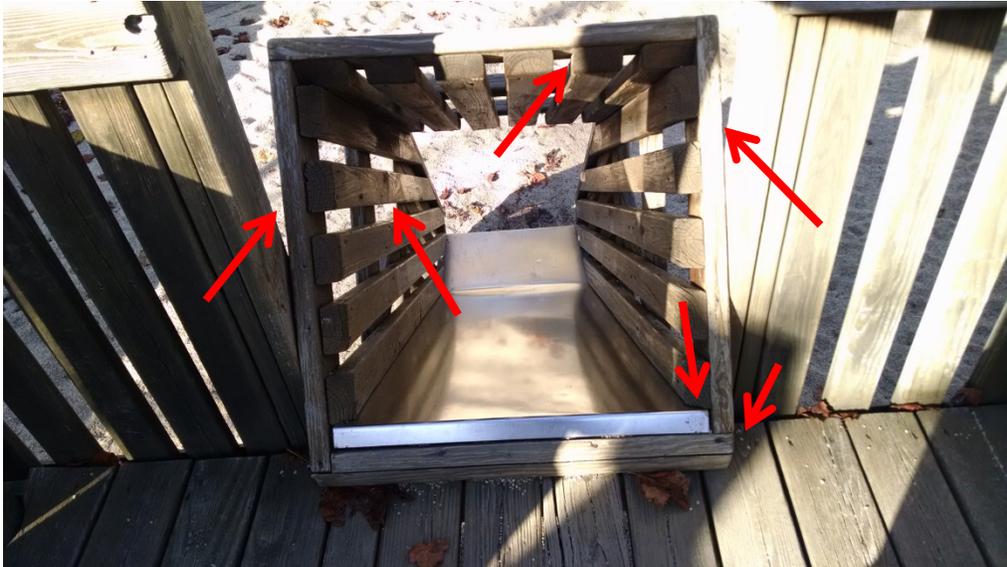
North slide on section 3 – Plenty of entanglement hazards

Entanglement hazard – “S” hook

As well, several improperly closed "S" hooks were found that also create a similar strangulation hazard. These should be repaired or replaced immediately.

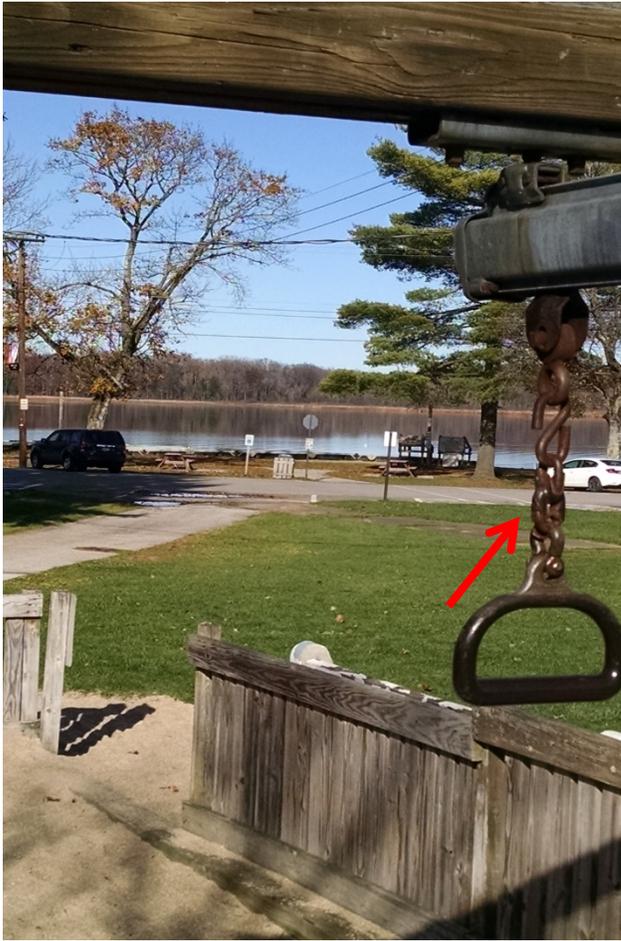
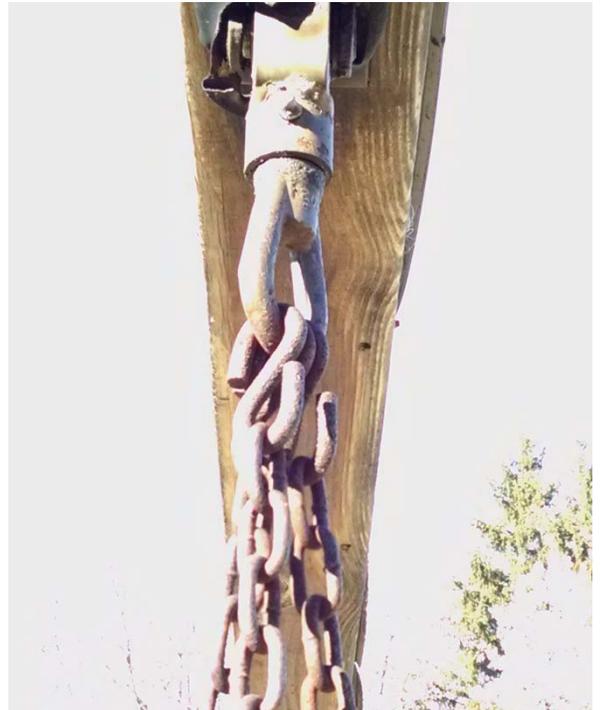
“S” hook and nail entanglement hazards on swing set. Similar “S” hook issue on tire swing

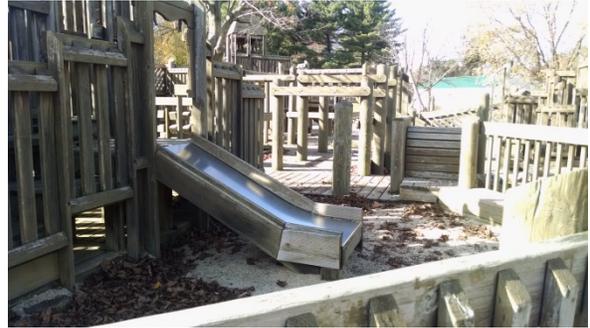
Short drop slide

1. See previous section describing entanglement hazards on this slide.
2. Metal surfaces are susceptible to extreme heat with possibility to burn a user's legs.
3. No enclosure at the slide entrance to funnel the user to a seated position.
4. Use zone does not extend at least 6' from the side and ends of the slide. Too close to the nearby bench.
5. Wooden side rails create a significant potential for splinters in the users hands and legs.

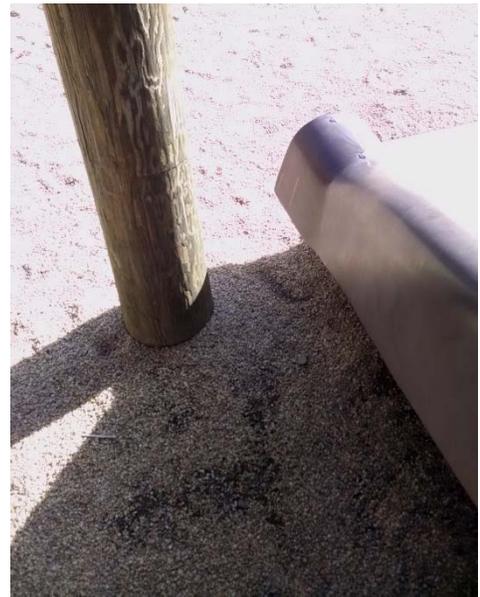
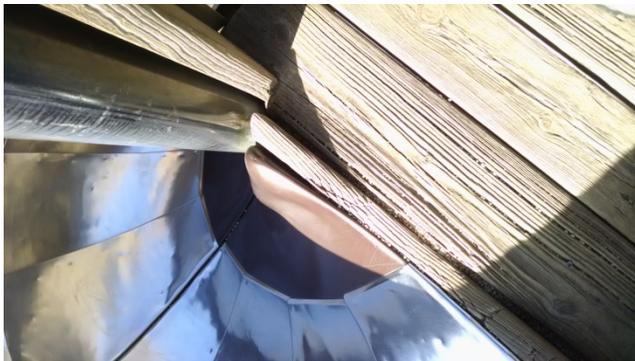
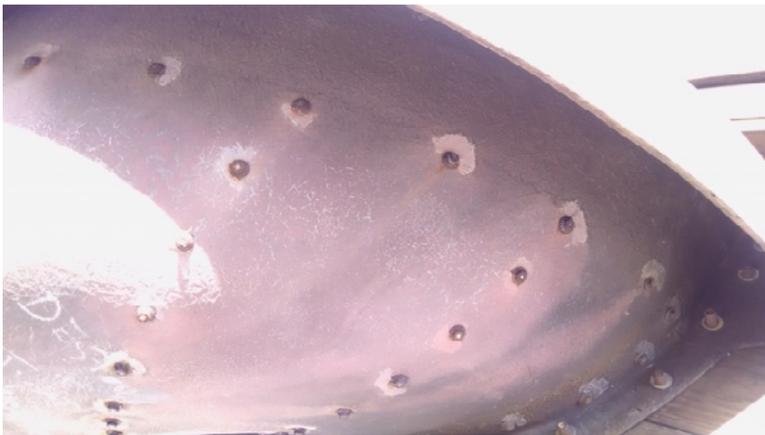
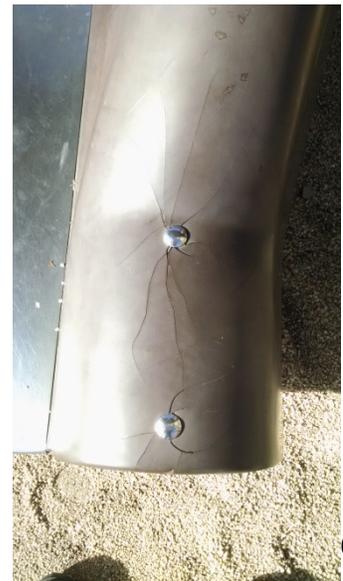
Spiral slide

1. See previous section describing entanglement hazards on this slide.
2. Non-compliant with the requirement of an obstacle free zone which extend upward and to the sides of all slides. Support pole is within the require 21".
3. Slide bed has entanglement hazard gaps in the bed, surface cracking, and rusted bolts.

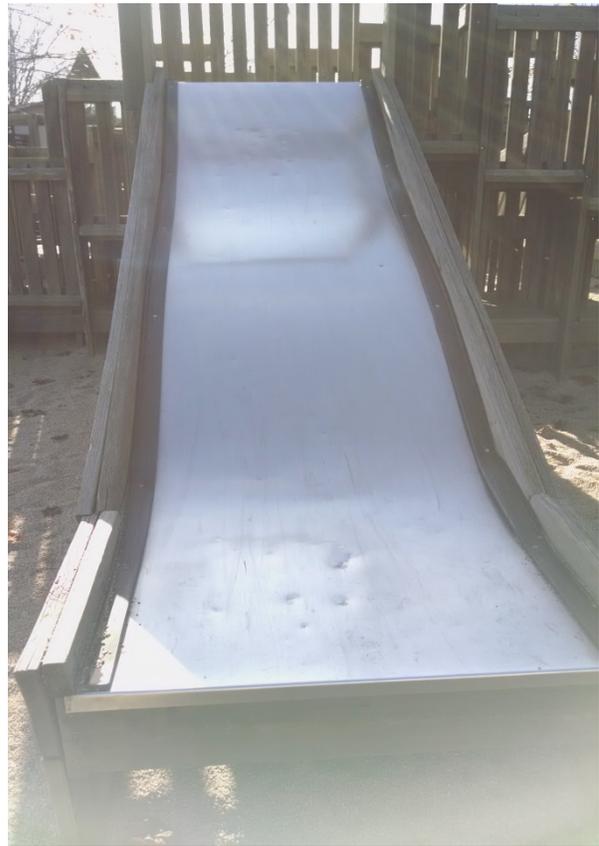
Large drop slide

1. See previous section describing entanglement hazards on this slide.
2. Metal surfaces are susceptible to extreme heat with possibility to burn a user's legs.
3. No enclosure at the slide entrance to funnel the user to a seated position.
4. Inadequate barrier at top of slide.
5. Plastic molding strips that have been inserted between the slide bed and side rails creates an entanglement hazard. If it has been installed by the Borough, they would be liable for any injury suffered as a result.
6. Wooden side rails create a significant potential for splinters in the users hands and legs.

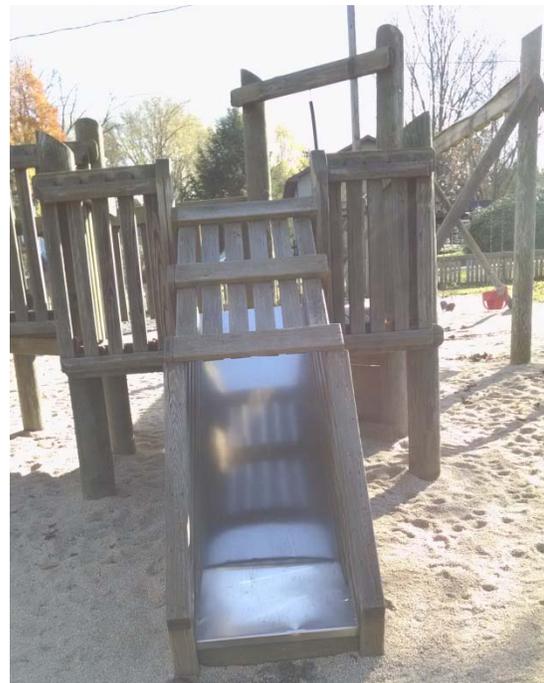
Wood Enclosed Slide

1. See previous section describing entanglement hazards on this slide.
2. Metal surface susceptible to extreme heat with possibility to burn a user's legs.
3. Wooden side rails and enclosure create a significant potential for splinters in the users hands and legs.
4. Wooden frame exposes the user to many opportunities to get hands, hair, and clothing caught between the wood slats. Because it is not a tube slide, all wooden sides and top would be within the 21" obstacle free zone for all slides.
5. There is a separation between two sections of the slide bed near the bottom, creating a potential shear or entanglement hazard.

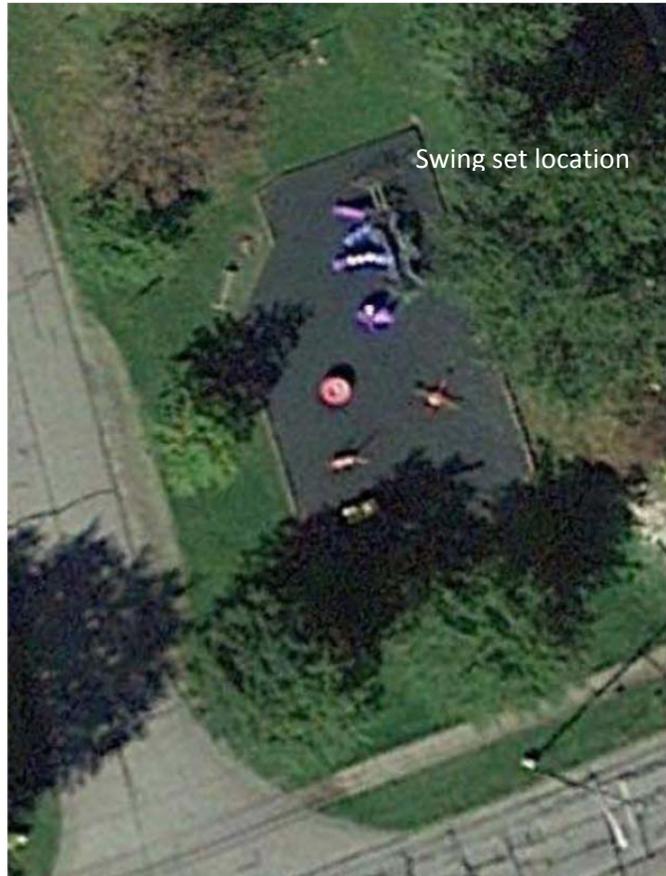
1. There was no safety surface under and around the swing set. As is noted on page 7 of this report, improper protective surface is the number one concern identified in *The Dirty Dozen* list of unsafe conditions.

2. The S hooks that join the swing chain to the top bar were not installed and/or closed properly, creating an entanglement/strangulation hazard for children using the equipment.

3. Over time, the top crossbar of the swings had weakened creating an a hazard to users. An attempted to repair the weakened bar was made by installing a 4"x4" wooden beam across the top of the bar. While this may have strengthened the bar, it created an additional liability to the Borough since it was not in compliance with the manufacturer's specifications for the swings.

4. Upside down U bolts were used to mount the wooden beam to the crossbar. When this was done, the U bolts protruded upward creating an additional entanglement or strangulation hazard at that location.

Based on the recommendation of the CPSI, that piece of equipment has already been removed from service.

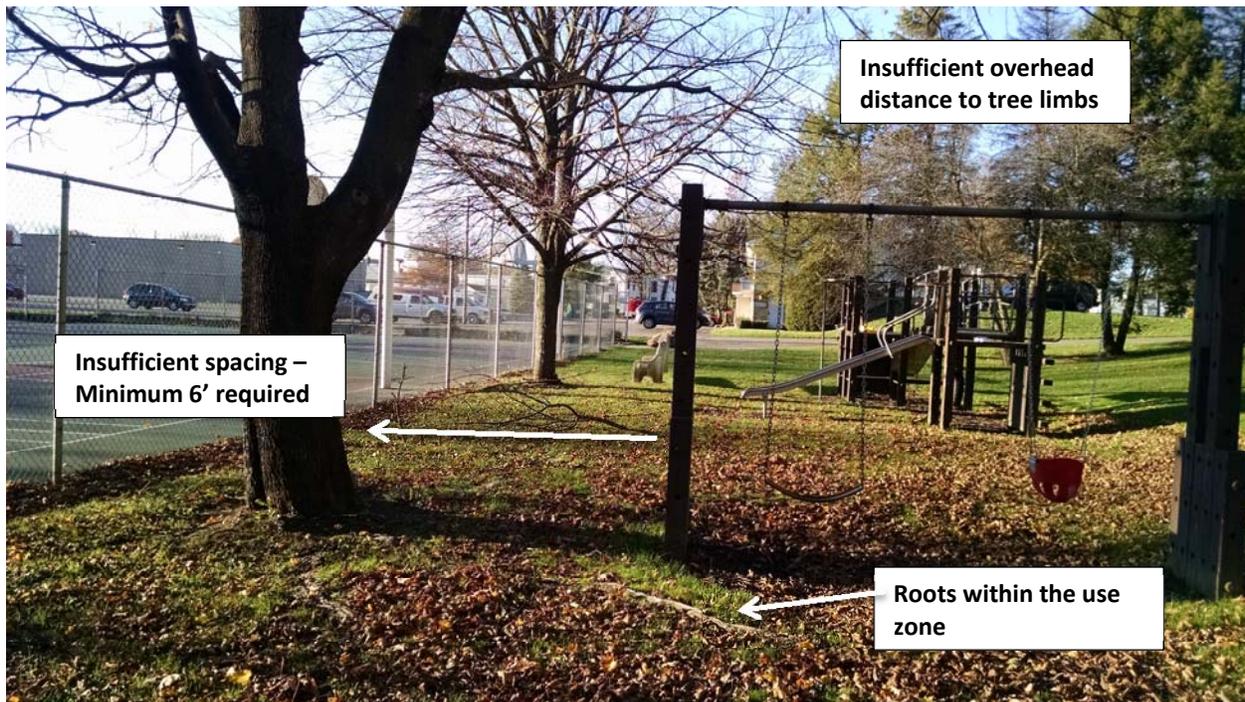
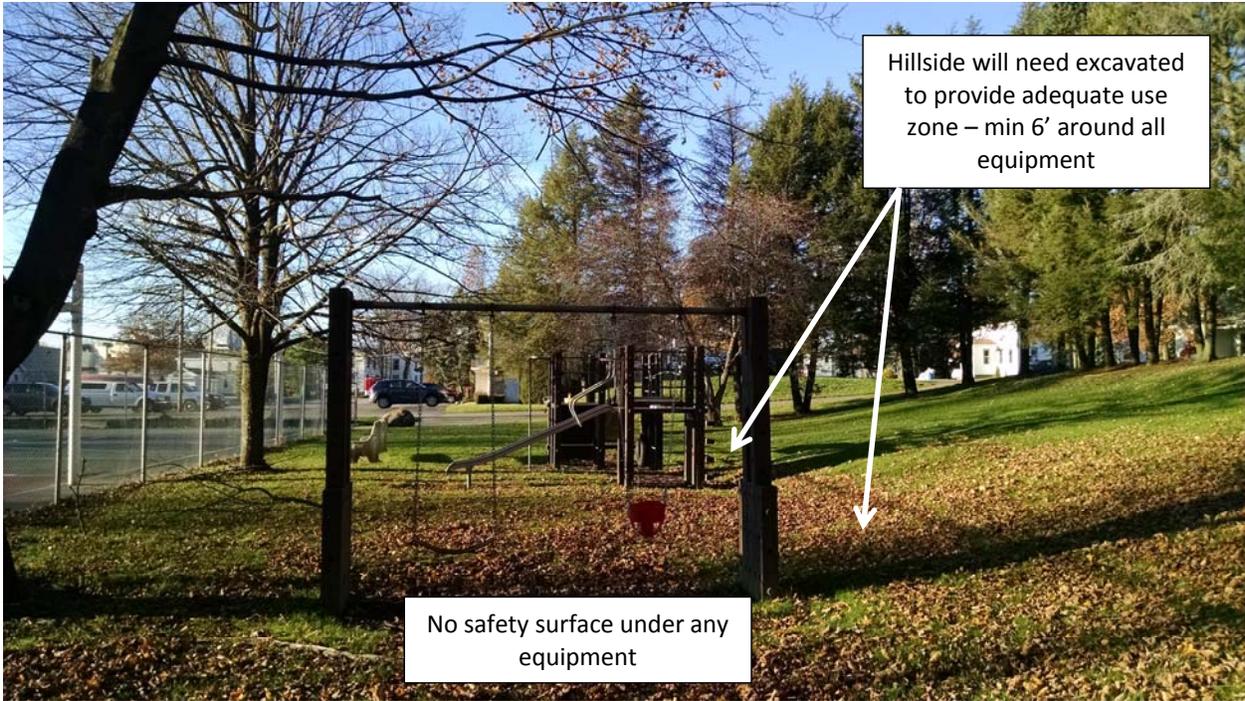
There is no safety surfacing surrounding any of this equipment.

The entire surface underneath and around the equipment is grass and dirt. These are not acceptable surfaces for playground areas. A list of acceptable surface material can be found on page 7.

In addition to the lack of safety surface, there are exposed roots from a nearby tree within the use zone of the swing set. And the swings are located too close to the trees. Also, there are trees hanging within the overhead portion of the use zone.

In order for the use zone to the upper side of the play unit to be compliant with safety surfacing, the hillside will likely need to be excavated to provide a fill 6' of use zone and surface. Though there is no adequate safety surface, the use zone on other sides are compliant with a minimum of 6' of space in all directions for the play set.

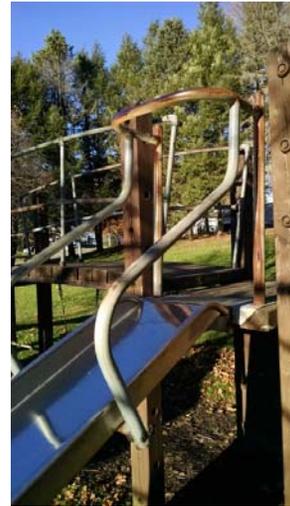
Slides cannot have any obstacle within 21” of the edge of the bed. The handles/bars in the photo are considered non-permitted obstacles

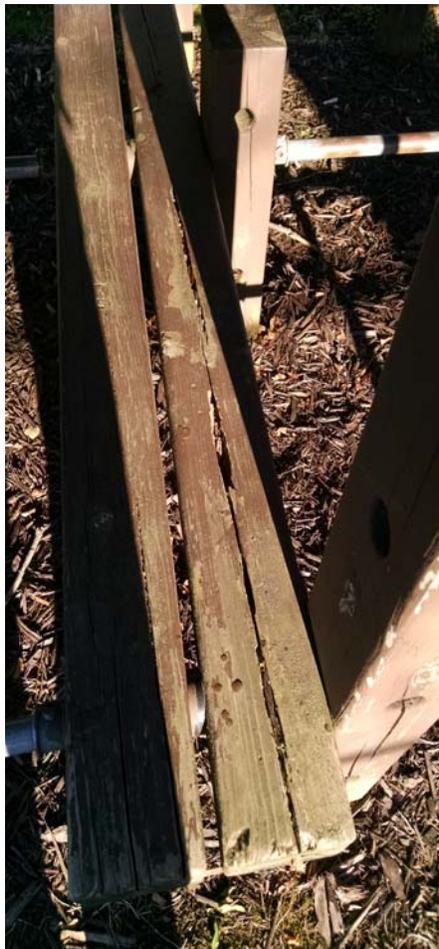
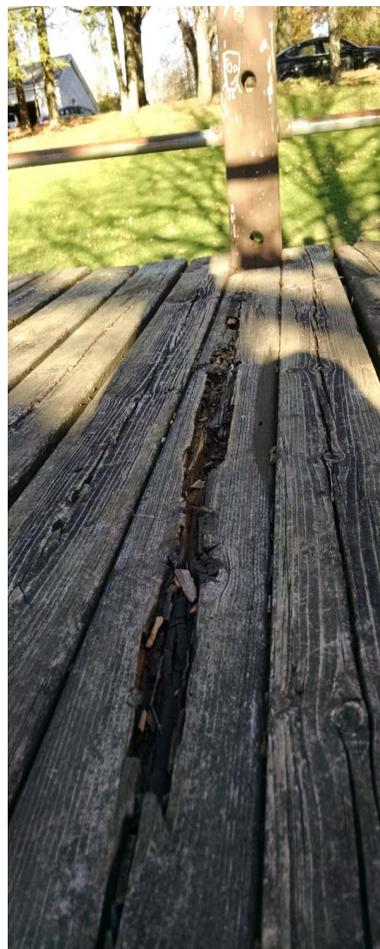
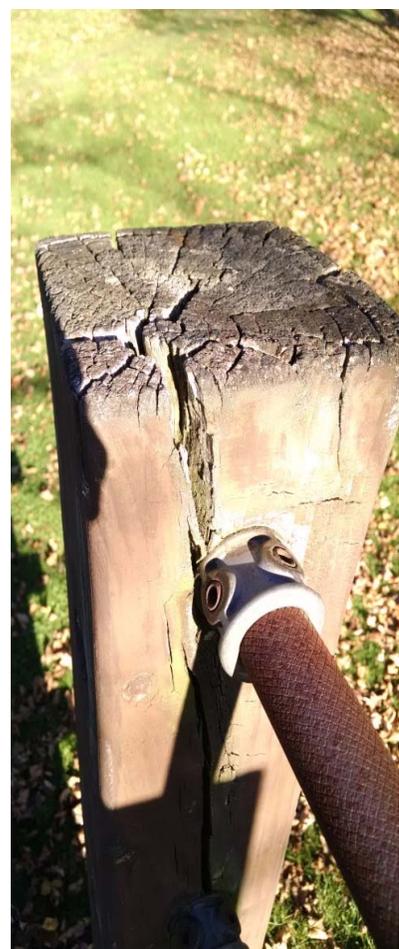
Sampling of Deteriorating decks and posts

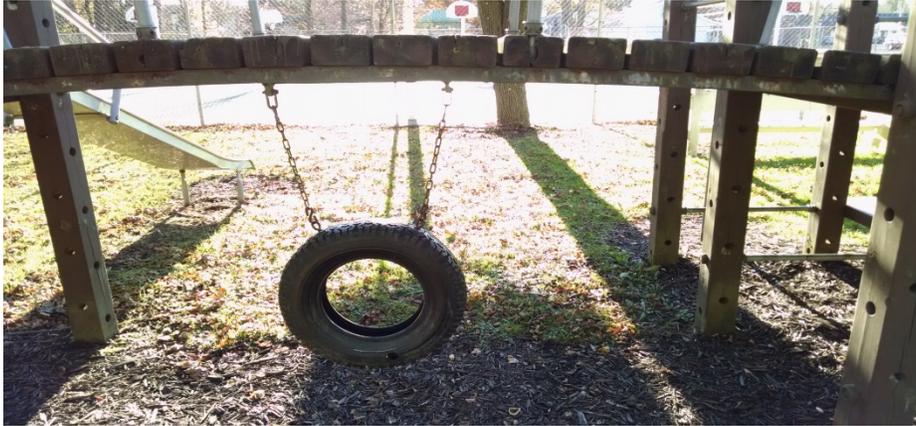
1. Swing guidelines require that swings within the same by be of the same type – either belt swings of enclosed swings (see previous picture). And cannot be attached to composite structures.
