**Report of the
Playground Safety and ADA Audit
For the Billings Park Playground
Edinboro, P
November 2015**

**Audit and Analysis conducted by
Pashek Associates
Community and Recreation Planners,
Pittsburgh PA**

Billings Park Playground

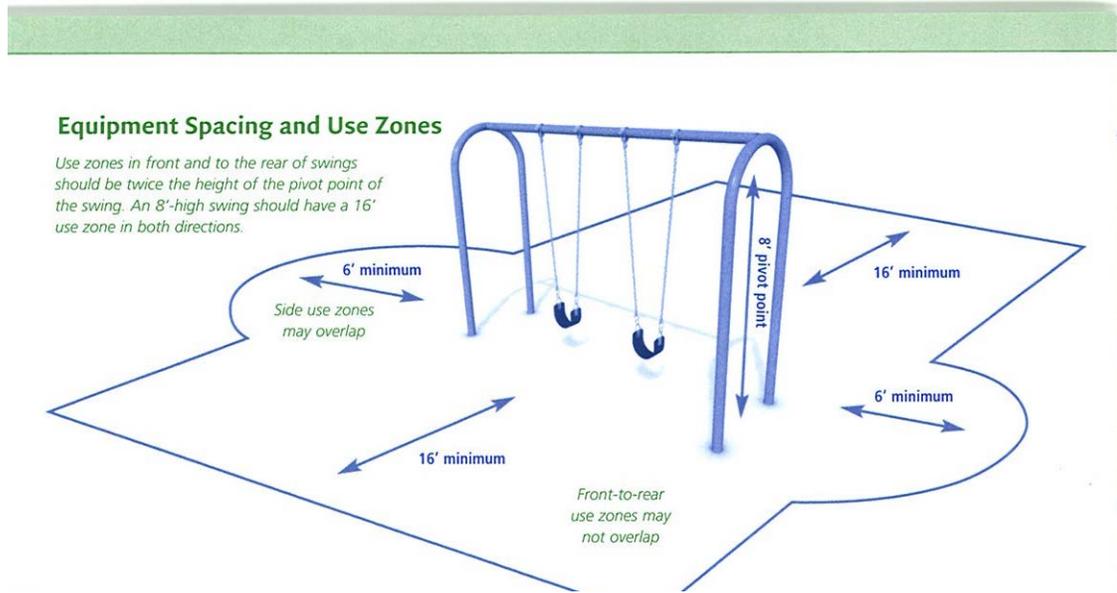
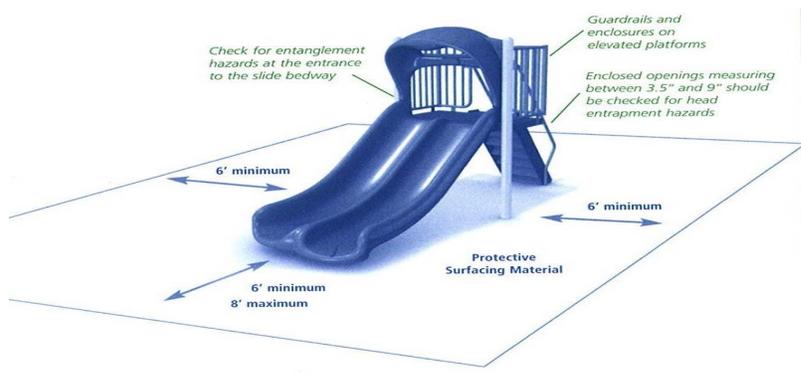
Tot Swing Use Zone

- A fully enclosed tot swing requires less of a use zone than school-age swings.
- Measure the vertical distance from the bottom of the seat to the pivot point or swing hanger and multiply by two for the use zone in front and back of the swings.

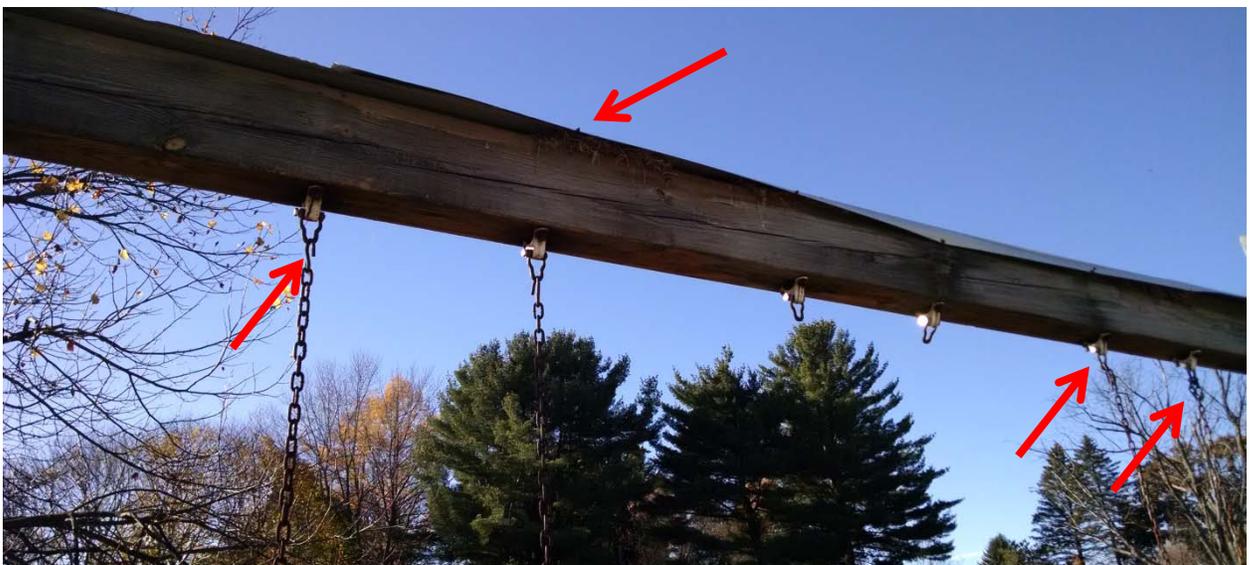
“S” hook and nail entanglement hazards on swing set. Similar “S” hook issue on tire swing

Checking and repairing "s" hook issues.

1. Checking Loops for 0.04in. (1.0mm) gap
